**US Army Corps
of Engineers®**
Engineer Research and
Development Center

South Jetty Sediment Processes Study, Grays Harbor Washington: Evaluation of Engineering Structures and Maintenance Measures

April 2003

Final report

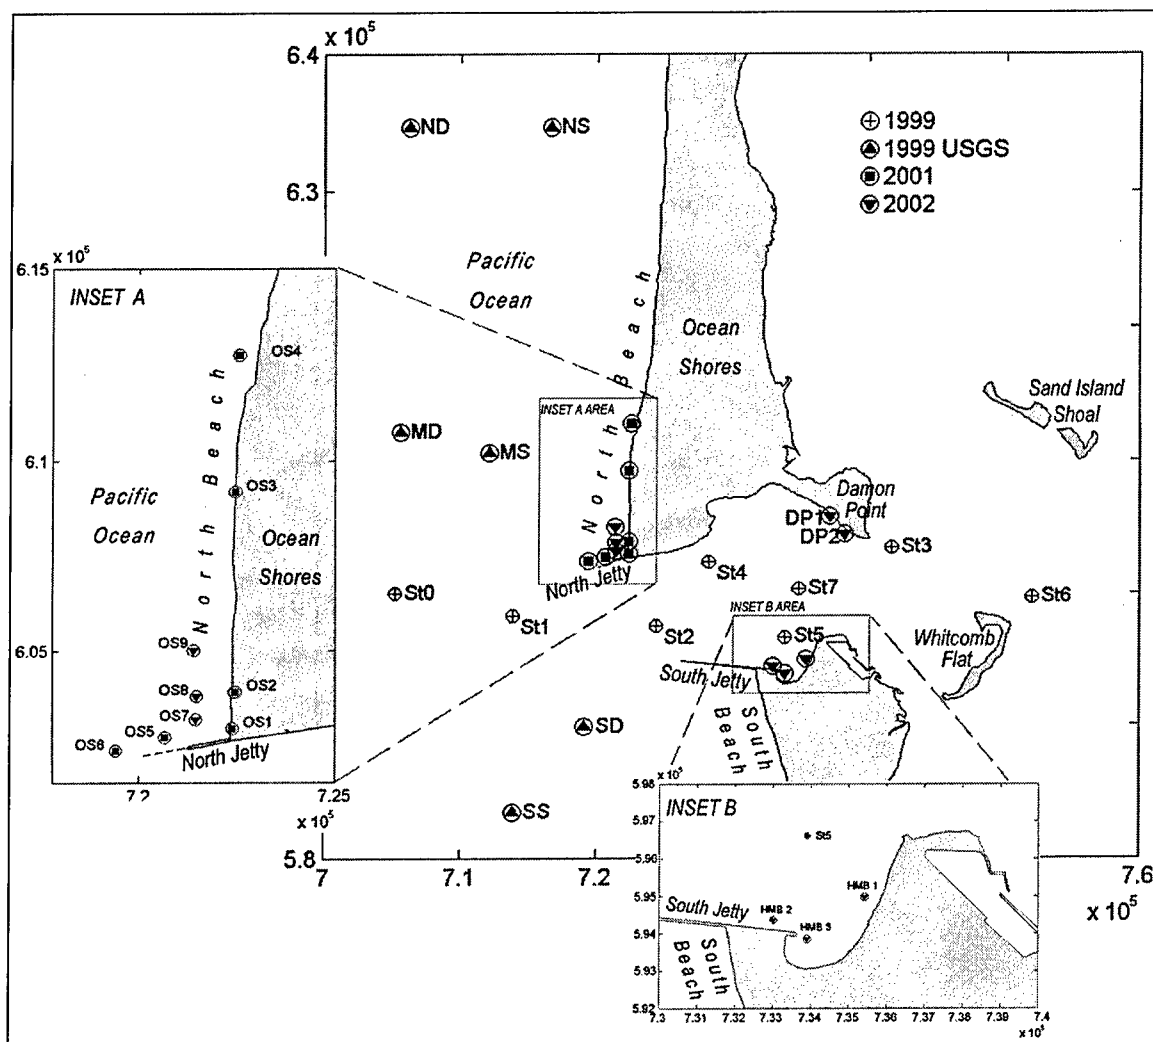
Figure 28. Location of instruments deployed in Grays Harbor

Between September and November 1999, eight instrumented tripods were deployed in the inlet entrance region of Grays Harbor. The tripod referred to as sta 5 was located in the outer Half Moon Bay area in approximately 9.5-m depth mllw (inset B, Figure 28). Directional wave gauges were installed at three locations in Half Moon Bay from 3 March to 29 April 2002 to document the directional wave field in Half Moon Bay and incident to the shoreline at the Point Chehalis beach fill. The pressure sensor on Gauge HMB3 did not function correctly, and Gauge HMB2 was not recovered, being lost in severe wave conditions. Therefore, wave data are available from Gauge HMB1, and near-bottom currents are available from sta 5, HMB1 and HMB3.

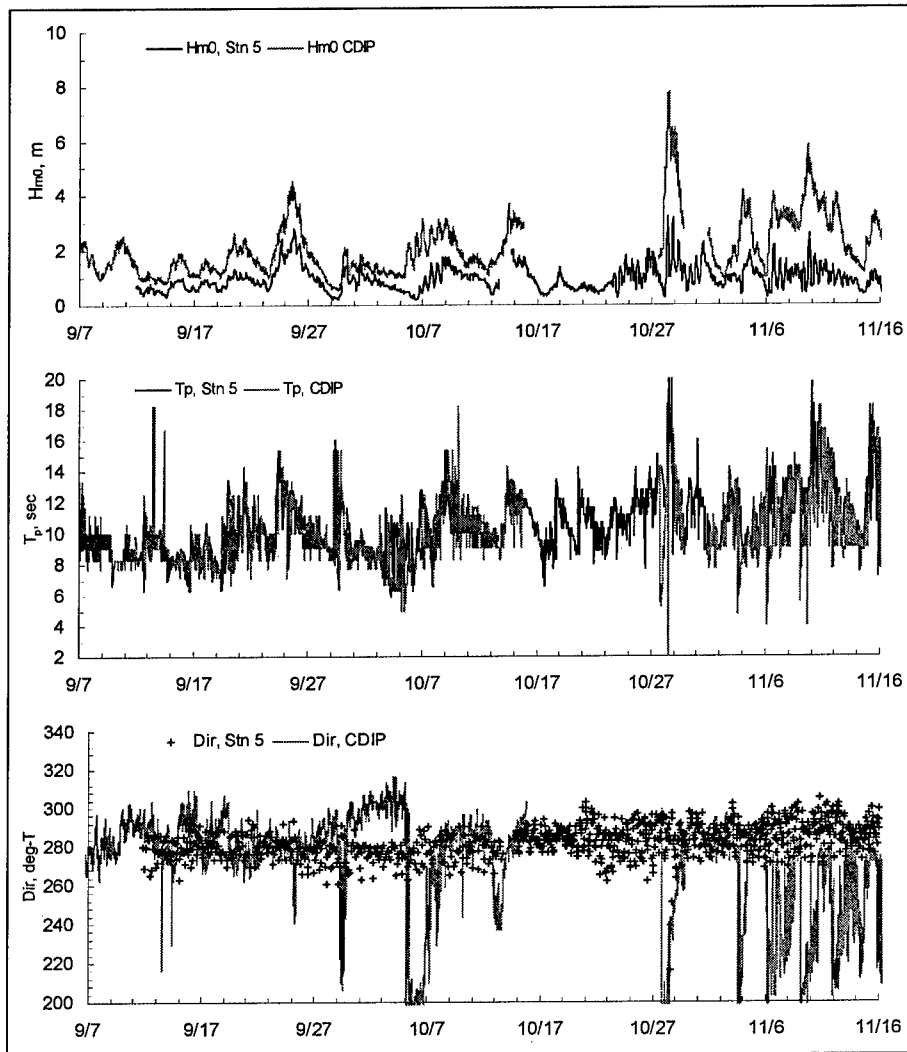
Figure 29. Time series of wave parameters at sta 5

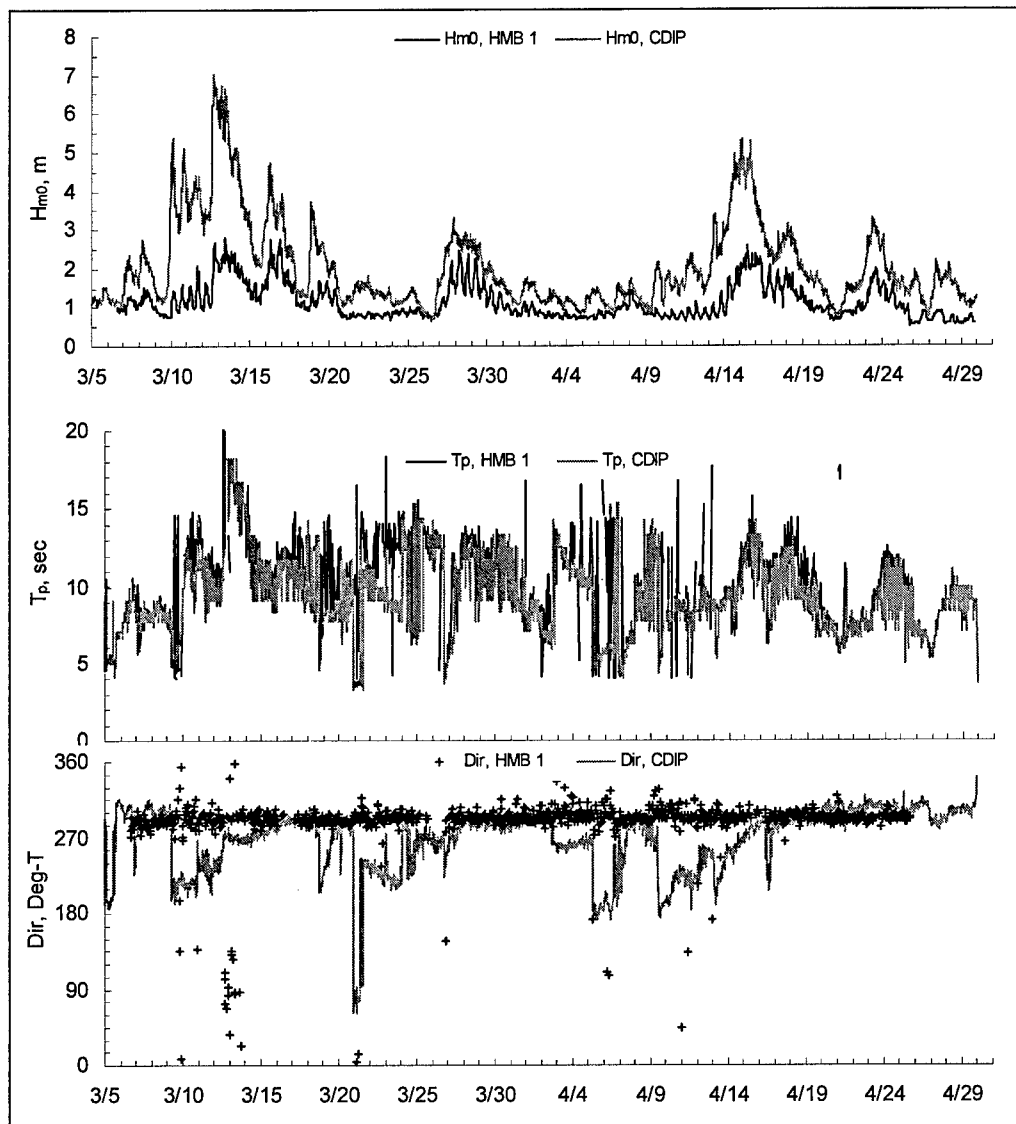
Figure 30. Time series of wave parameters at HMB1

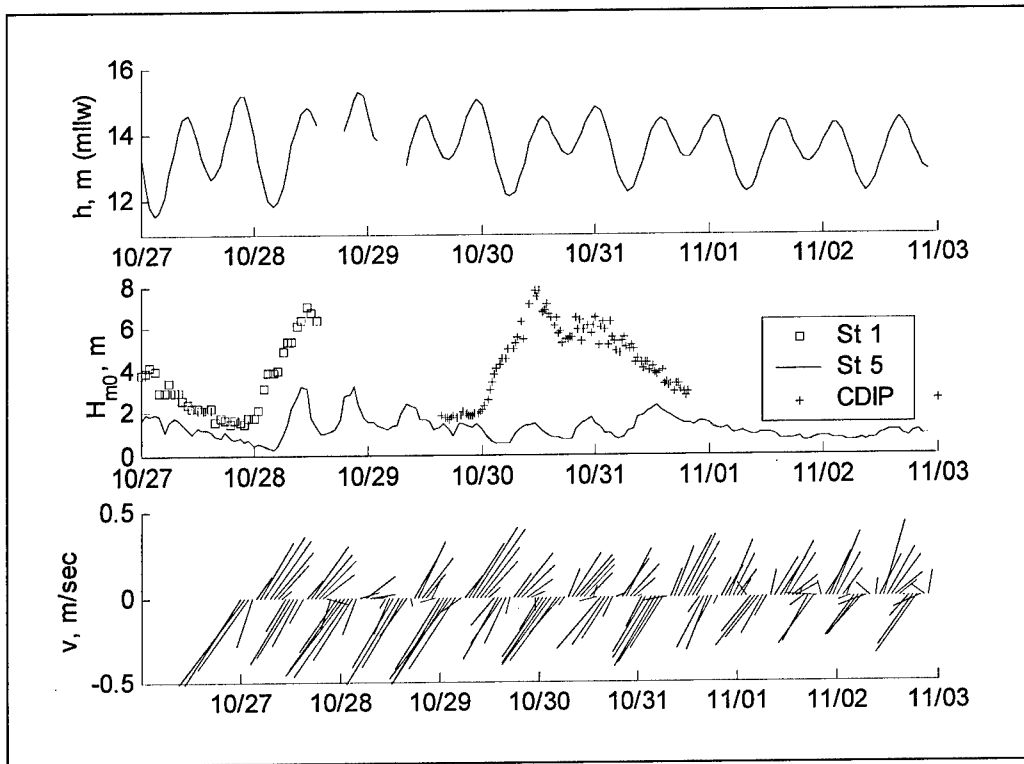
Figure 31. Time series of depth h , H_{m0} , and current vectors at sta 5 during a 1999 storm

Time series of current vectors at sta 5 during a storm between 27 October and 2 November 1999 are shown in Figure 31. Similar time series at HMB1 and HMB3 for a storm that occurred 10-15 March 2002 are shown in Figure 32. Despite the large waves, the mean current at sta 5 is dominated by tidal forcing and oscillates between northeast and southwest on flood and ebb tide, respectively. Peak ebb and flood currents at sta 5 are capable of eroding sediment from the bed. The net current is ebb dominated and directed southwest. Although there is tidal period modulation of the current at HMB1, the current speeds also increase and decrease with wave height. Current vectors during the storm are directed northeast approximately parallel to the shore. Currents are generally less than 0.1 m/sec except at the peak of the storm. At HMB3 the currents are significantly weaker (< 0.1 m/sec) than at HMB1, with net current to the northeast.

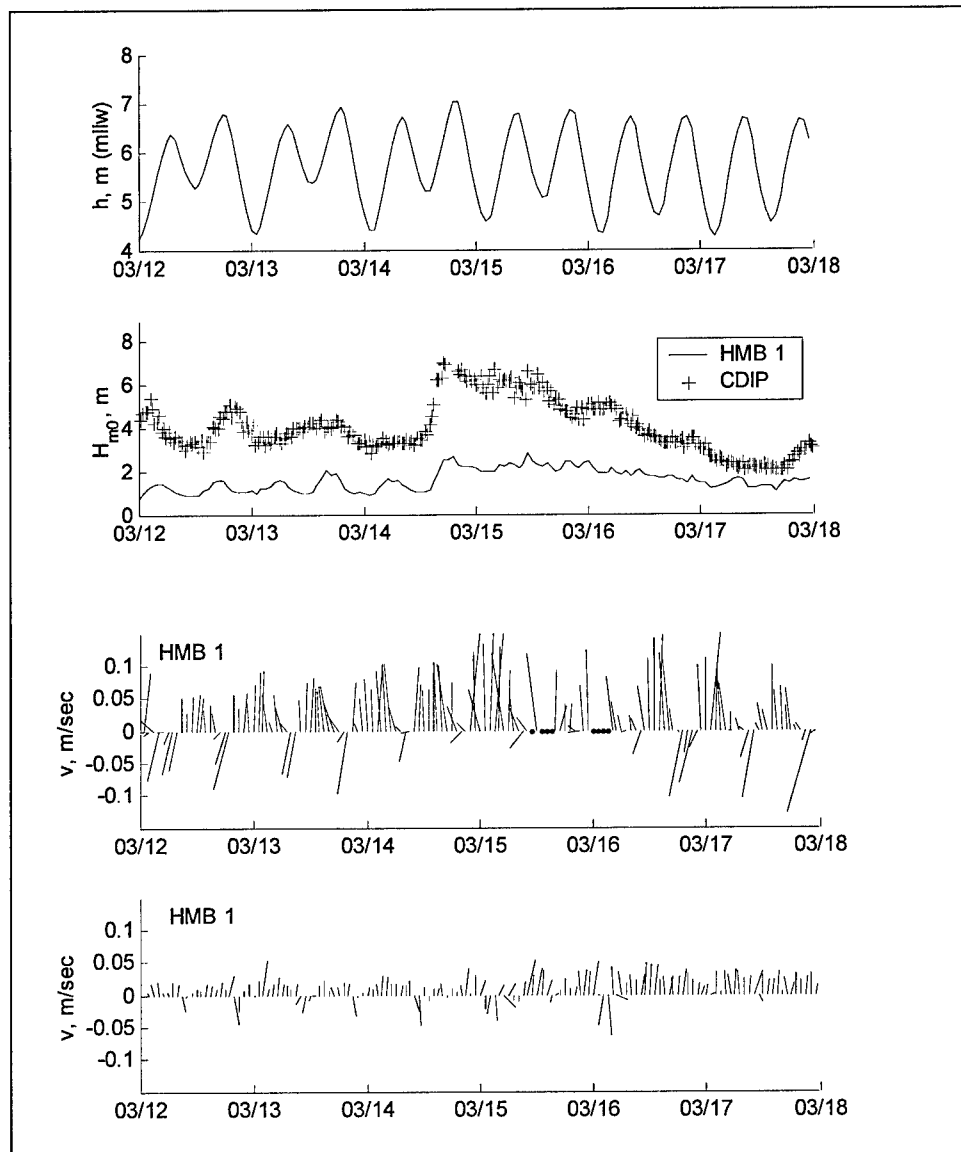
Figure 32. Time series of h , H_{m0} , and current vectors at HMB1 and HMB3 during a 2002 storm

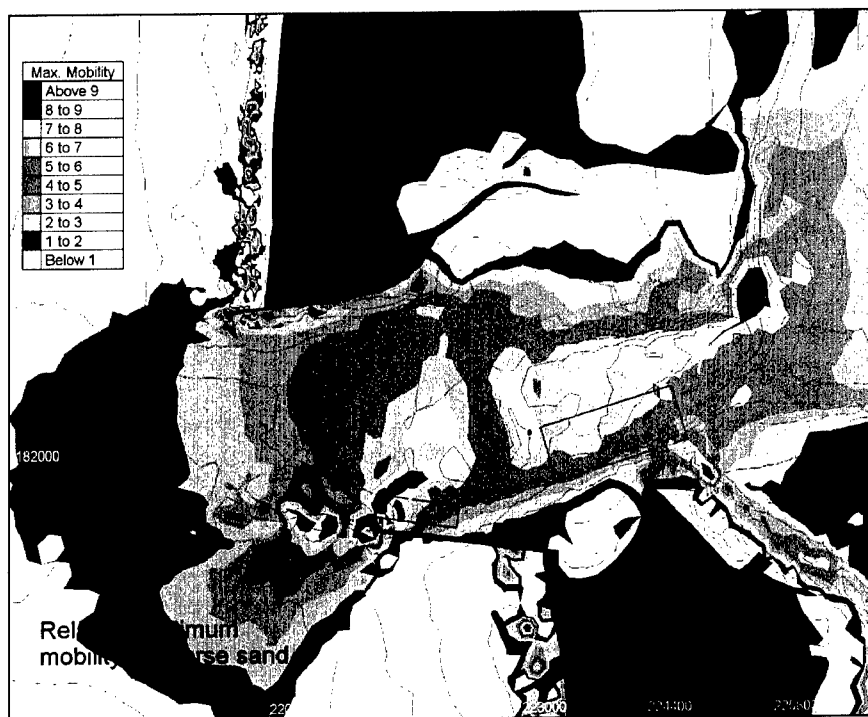
Figure 36. Relative mobility of coarse sand computed for maximum steady currents from 5-day simulation including tidal currents and waves (September 1999)

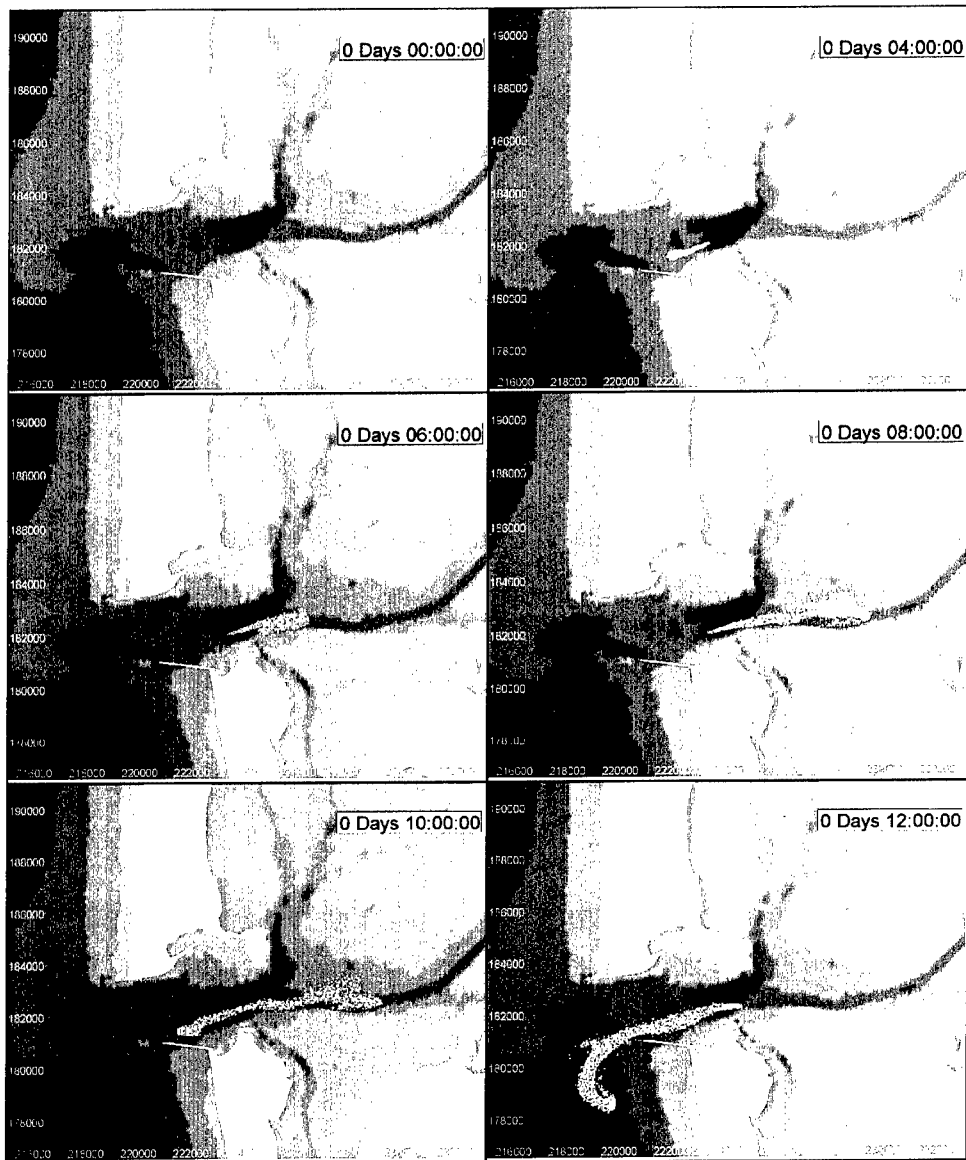
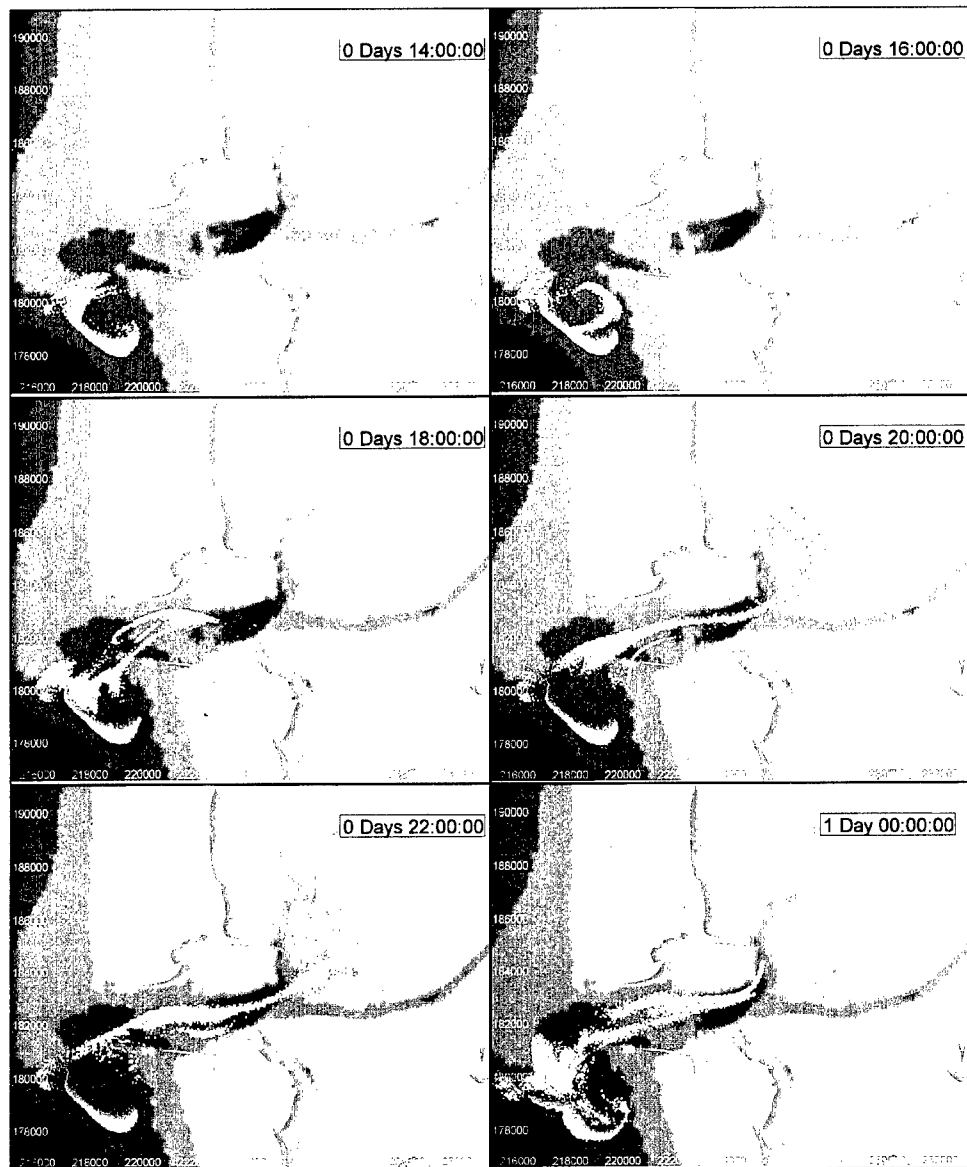
Figure 38. Frames output from the Lagrangian sediment transport model at 2-hr intervals for medium sand released at Point Chehalis disposal site (Continued)

The simulations indicate that the majority of sand particles are transported westward out of the inlet to the ebb shoal from the disposal sites by the ebb-dominated current in this region. A small proportion of medium and coarse sand particles is deposited in Half Moon Bay and also move onto tidal flats to the east and back into the navigation channel. These results neglect the contribution of wave orbital velocities to local bed shear stress in the calculation of transport.

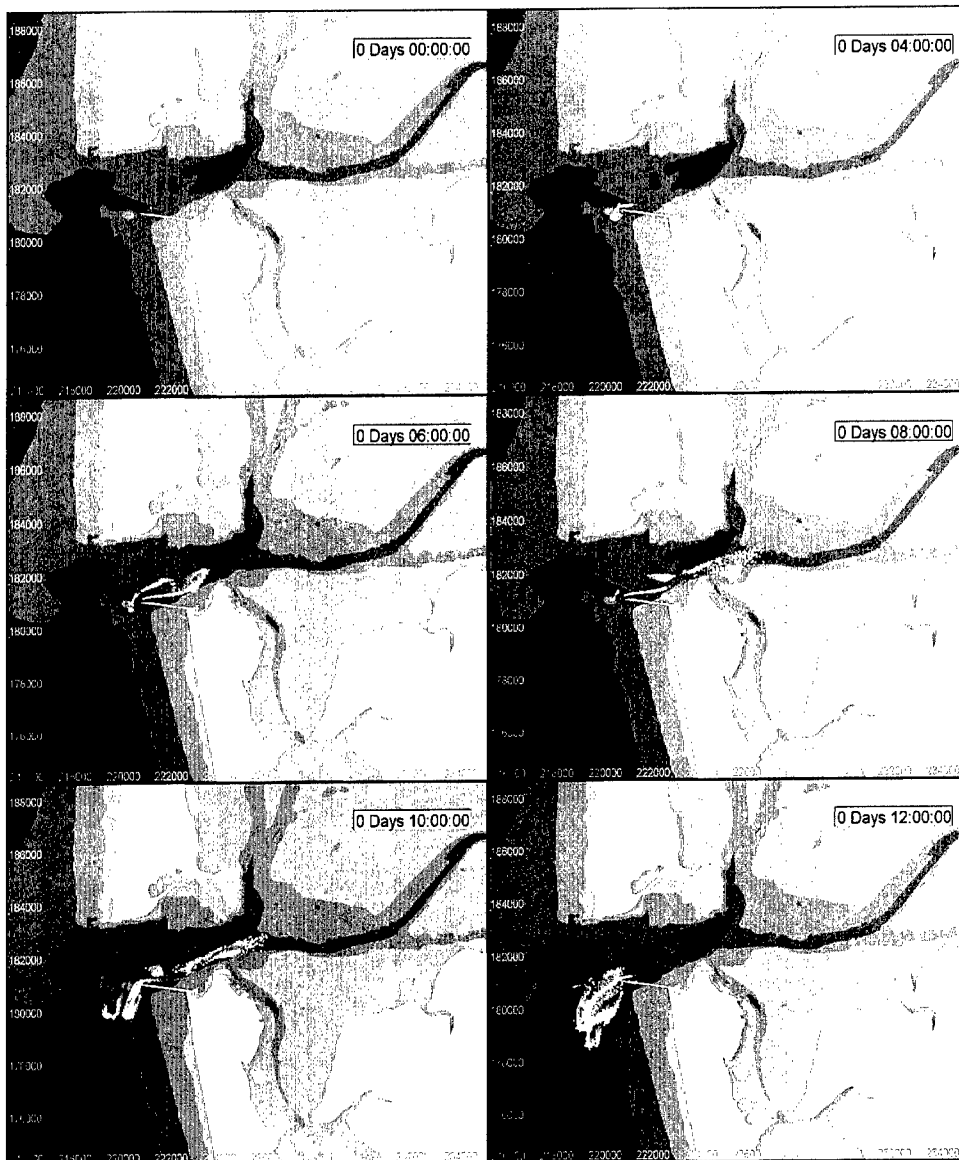
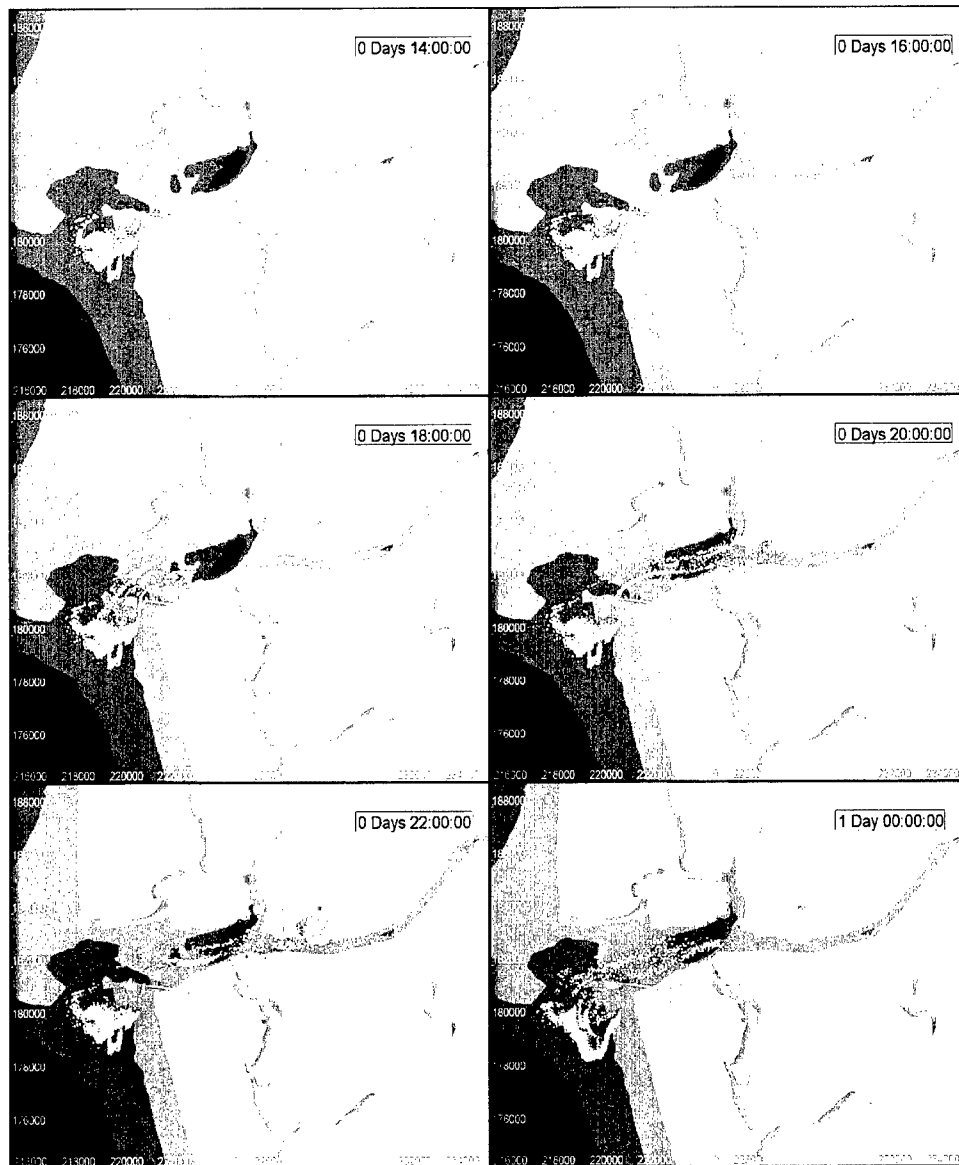
Figure 39. Sequence of frames at 2-hr intervals output from PSed module for medium sand originating at south jetty disposal site (Continued)

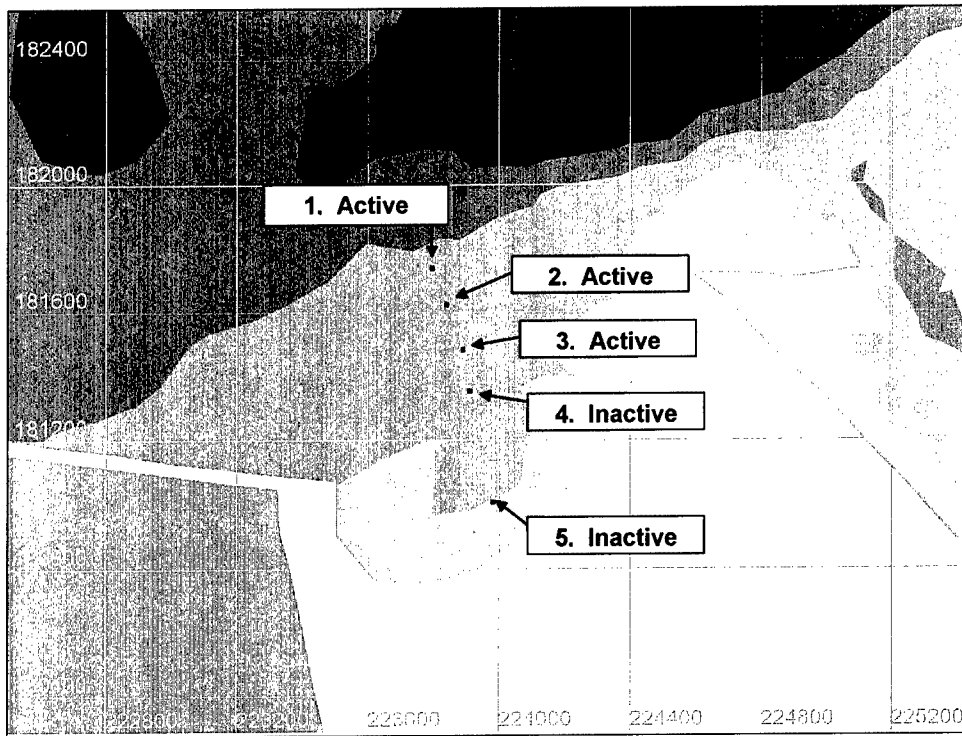
Figure 40. Location of active and inactive sites for sediment sources in PSed module for medium sand in Half Moon Bay

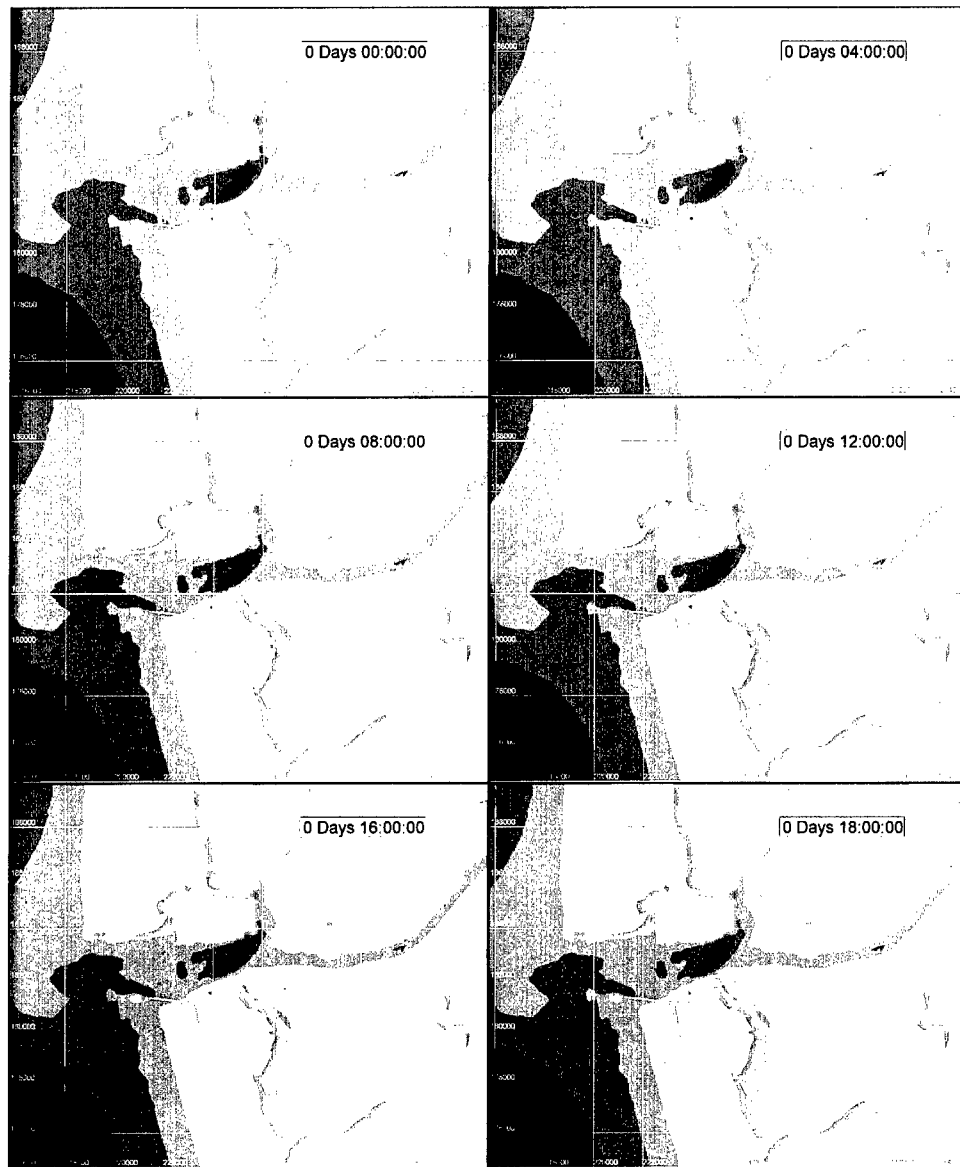
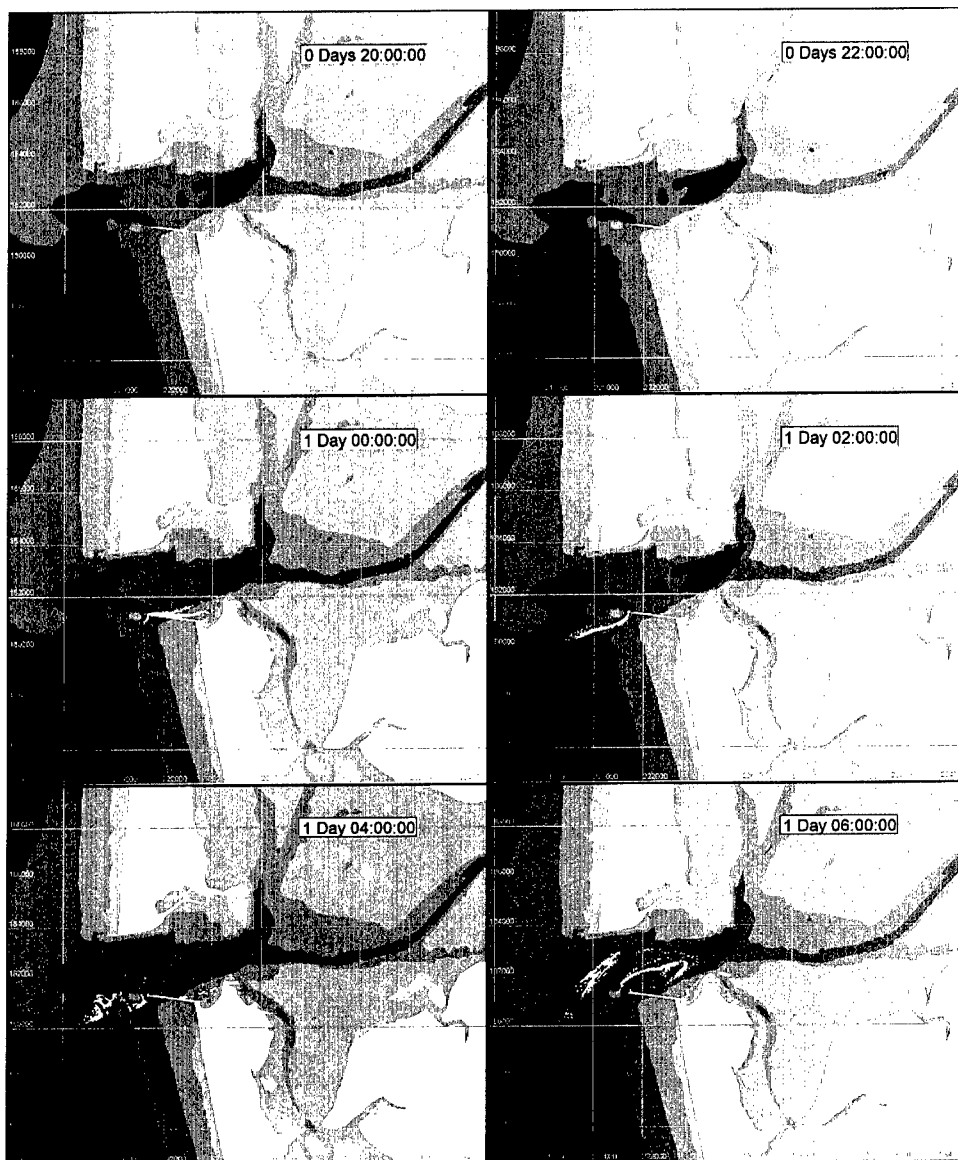
Figure 41. Sequence of frames at 4-hr intervals and then 2-hr intervals from PSed module for medium sand originating at Half Moon Bay disposal site (Continued)

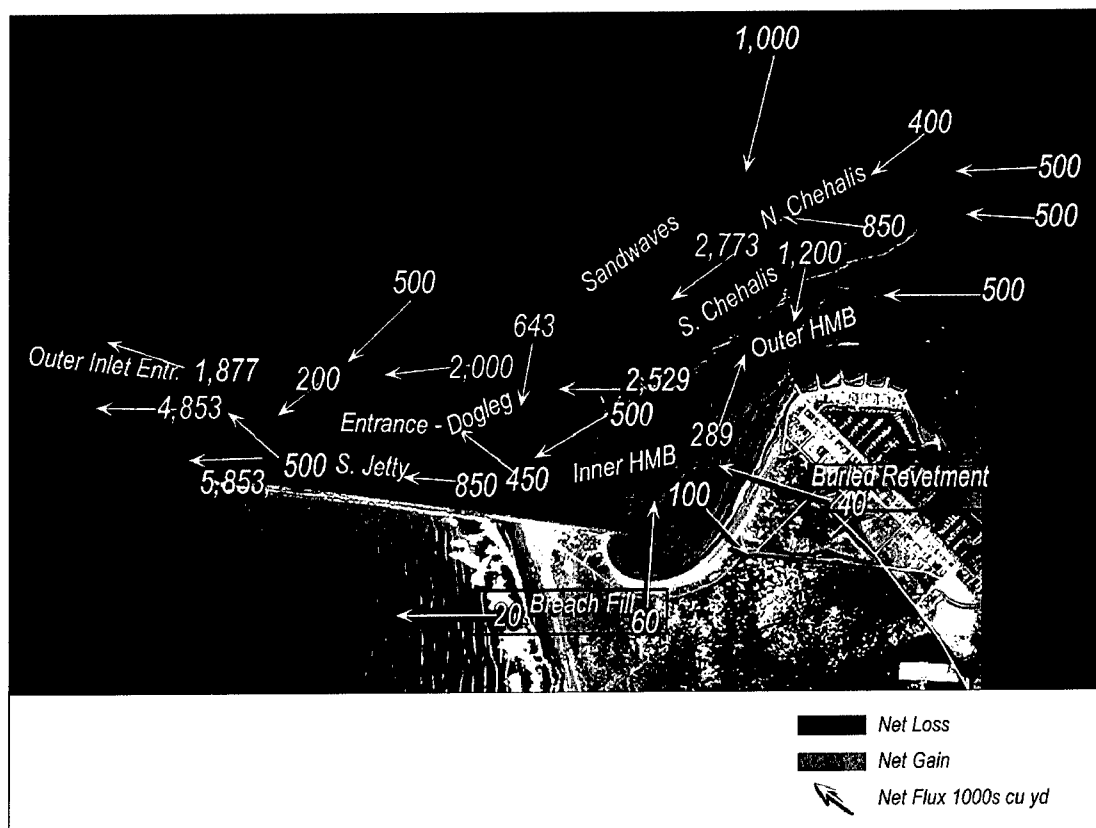
Figure 43. Sediment budget for Half Moon Bay/south jetty area developed from net morphology change between 1996 and 2002

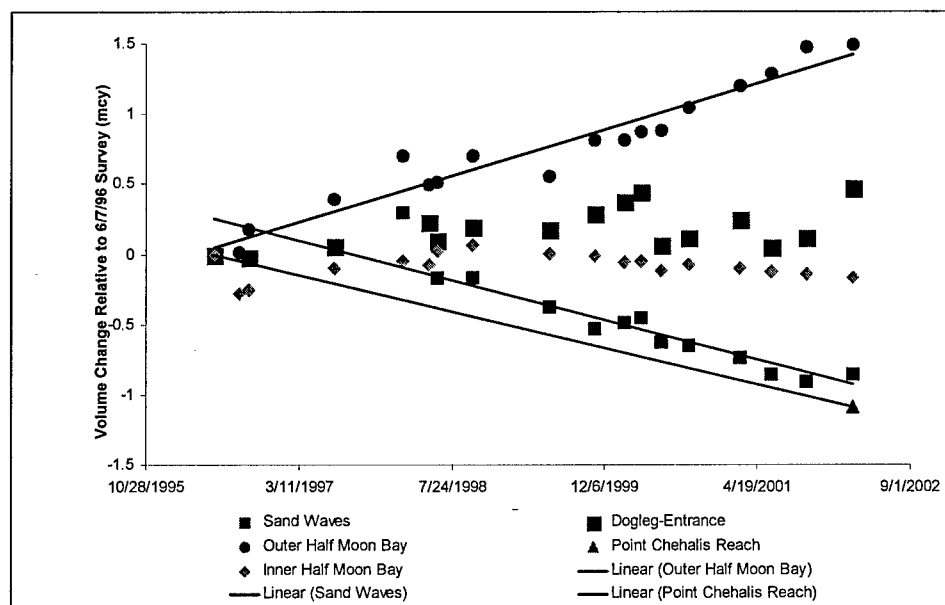
Figure 44. Time series of volume changes in erosion-accretion zones relative to 7 June 1996 survey

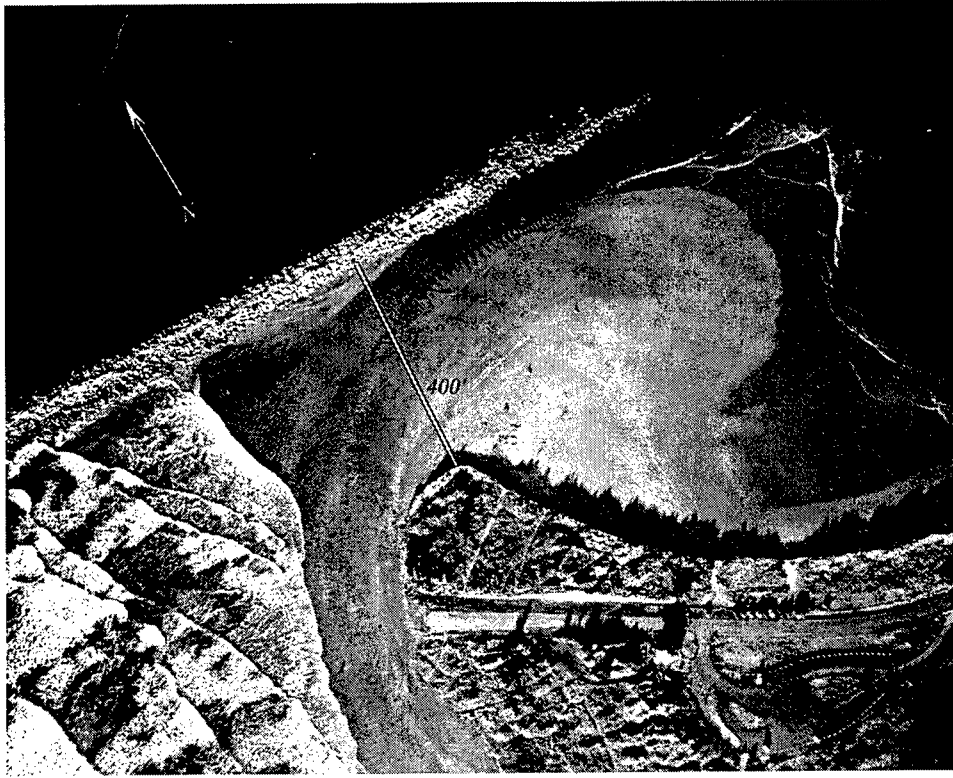
Figure A6. Breached area at Grays Harbor south jetty, January 1994

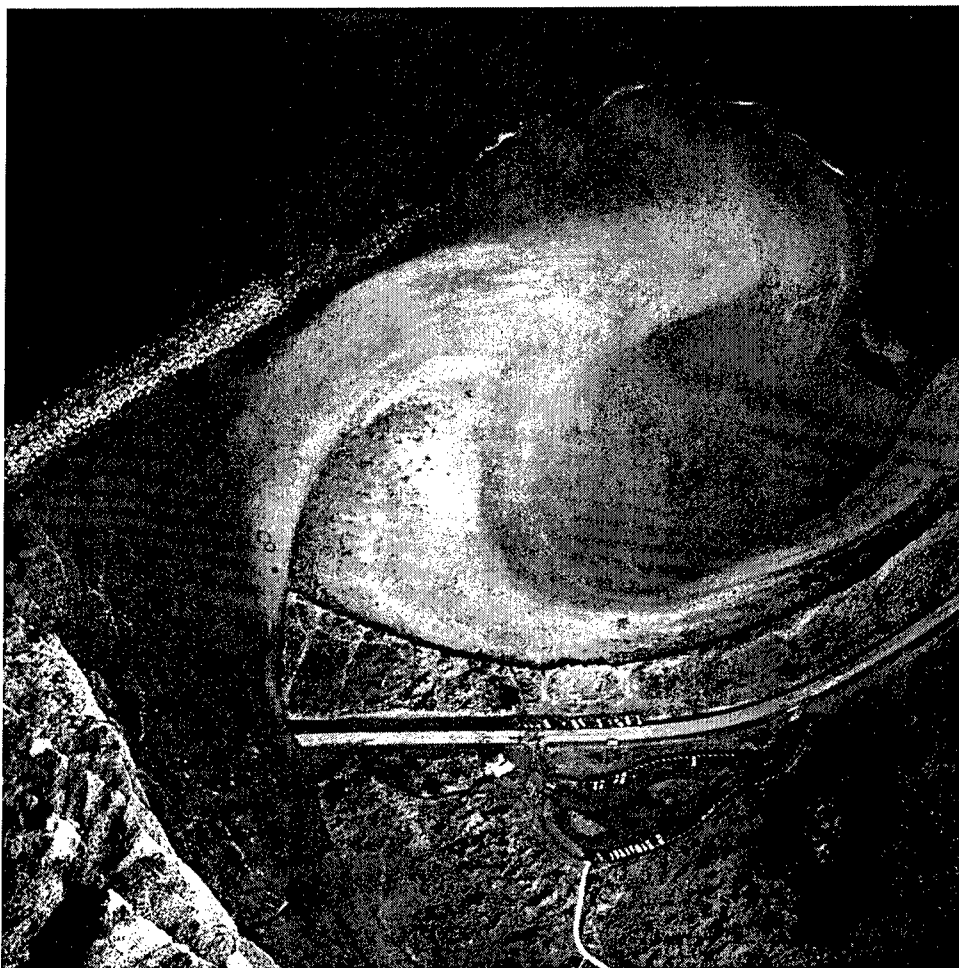
Figure A7. Breached area at Grays Harbor south jetty, 2 February 1994

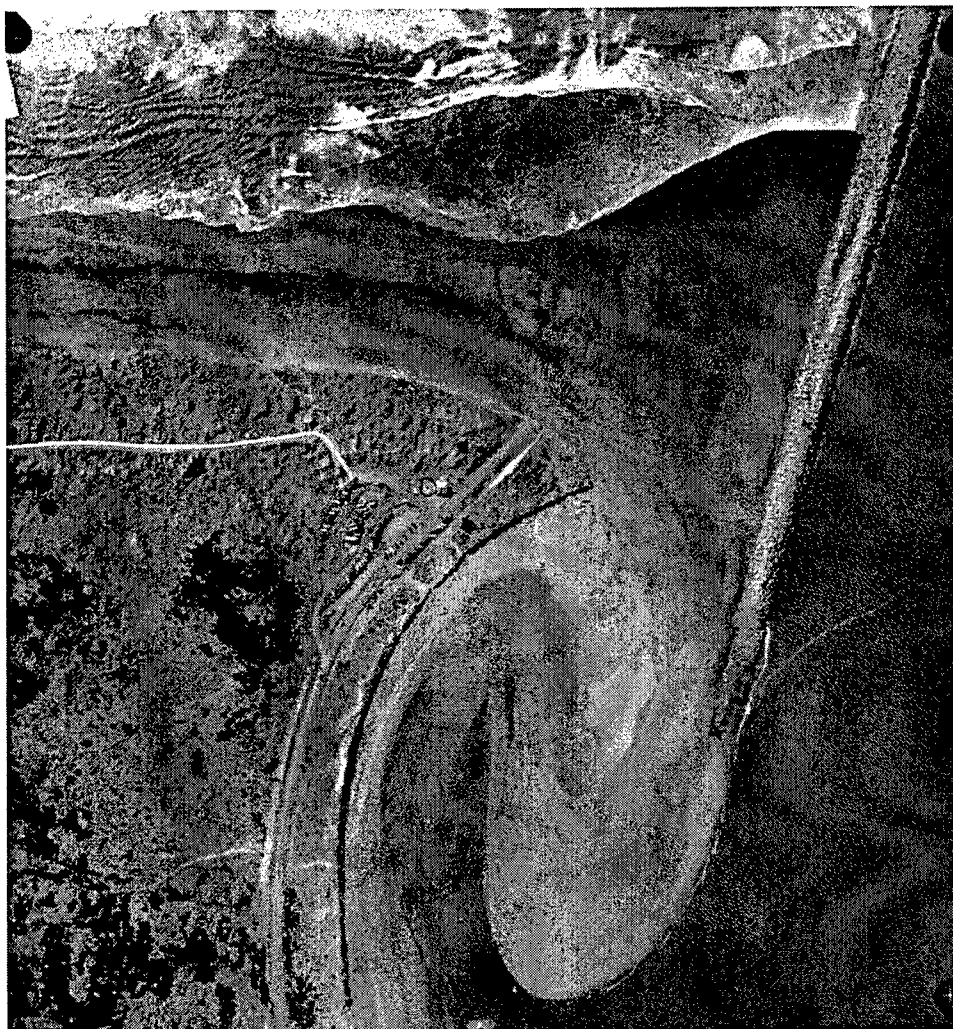
Figure A8. Breached area at Grays Harbor south jetty, 6 March 1994

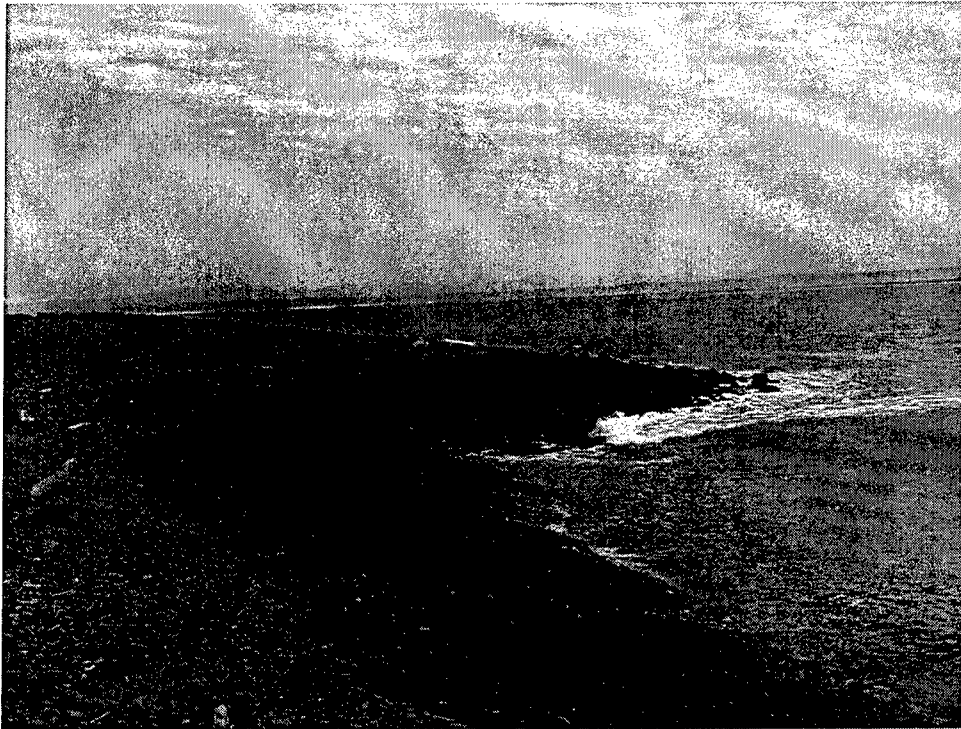
Figure A37. Wave diffraction mound, 6 March 2001

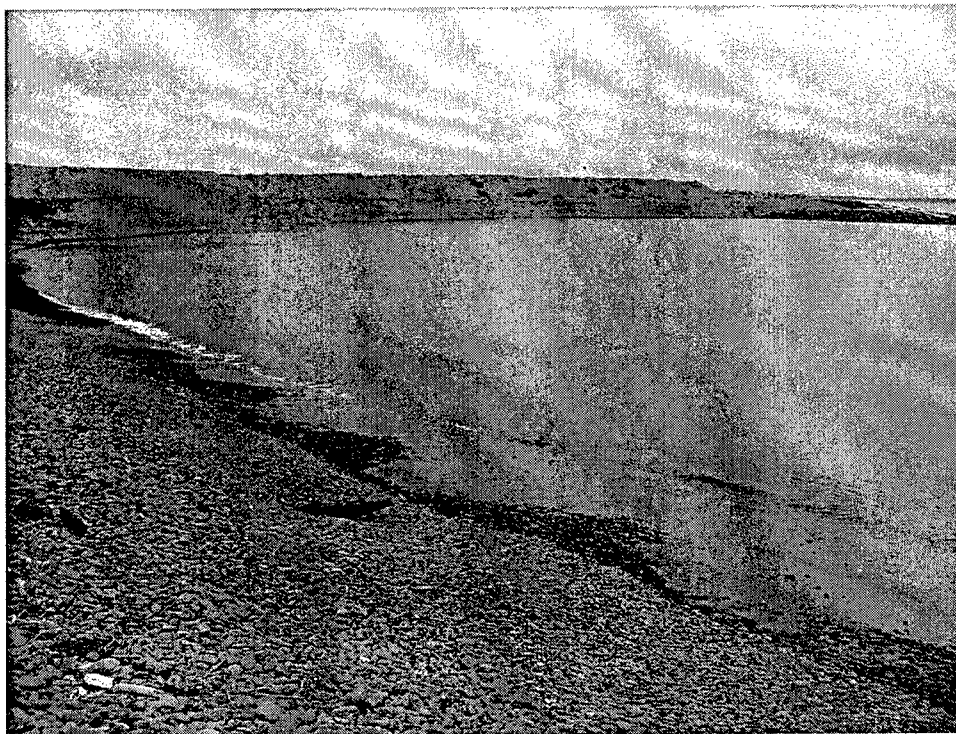
Figure A39. Half Moon Bay gravel transition zone and dune renourishment,
20 August 2002

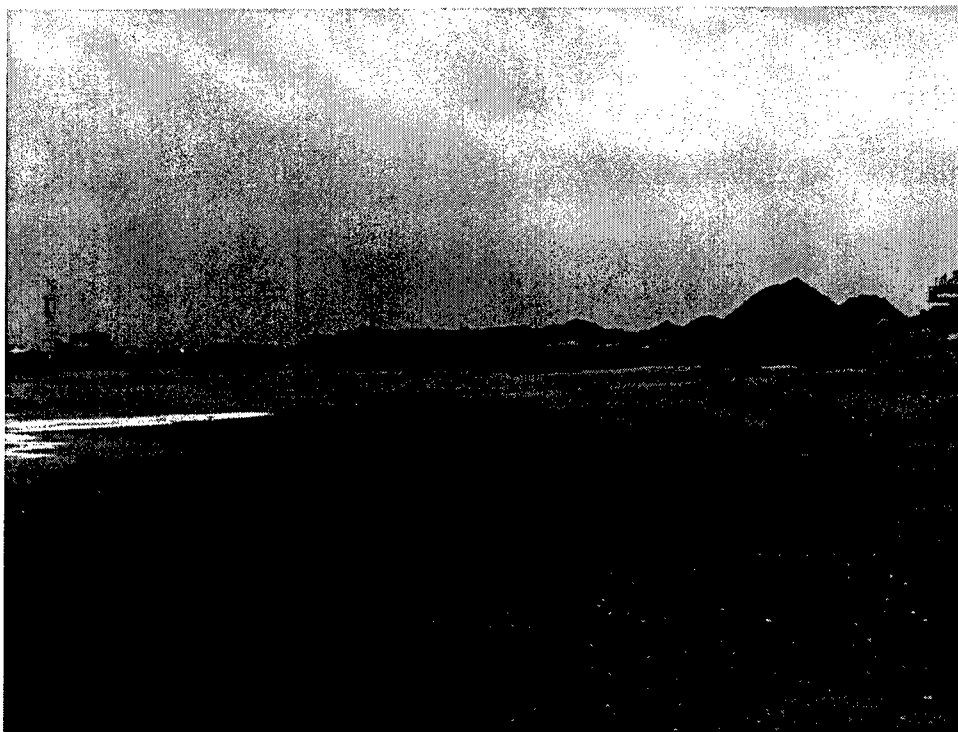
Figure A49. Point Chehalis revetment fill, 21 January 1999

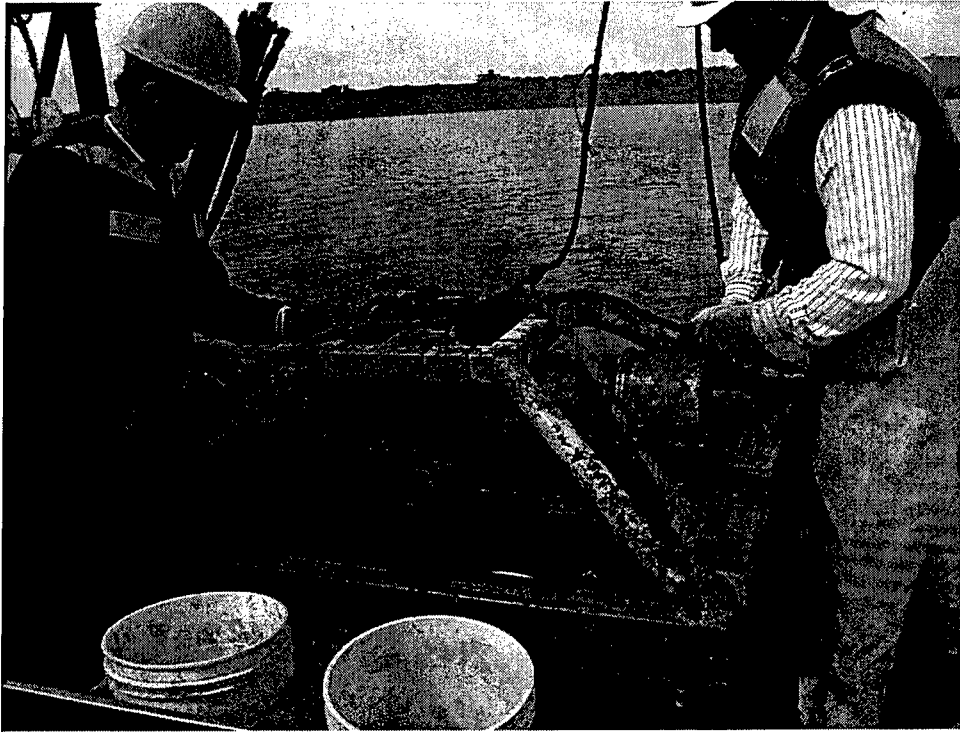
Figure A53. Wave gauge recovery Half Moon Bay, 30 April 2002
